Operating Experience Weekly Summary 97-26

June 20 through June 26, 1997

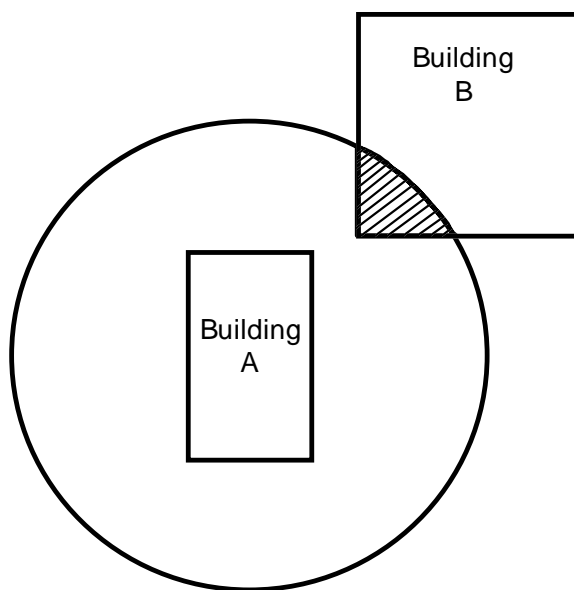
Figure 1-1. Area of Evacuation and Audible Alarm Coverage

On June 13, 1997, engineers identified a potential as-found condition during a drawing review of a proposed change to building criticality accident alarm system zone coverage areas. The current drawing for the first building coverage zone did not include any portion of a nearby second building. The drawing for a third building indicated the criticality accident alarm system in the first building covers a small portion of the north-east corner of the second building. Engineers identified a similar problem with two other buildings. The facility manager posted all identified coverage areas to restrict personnel entry pending verification of audible alarm indicators. Figure 1-1 provides a simplified illustration of how the criticality accident alarm system evacuation area and the audible alarm coverage of one building can overlap an adjacent building. Personnel located in the cross-hatched area of Building B would be affected by alarms in Building A.

These events illustrate the importance of personnel clearly understanding criticality accident alarm system evacuation areas and audible alarm coverage. Facility managers should ensure that personnel working in buildings that contain alarm systems, or in adjacent buildings that fall within the alarm coverage area, can hear alarms and understand announcements that require evacuation.

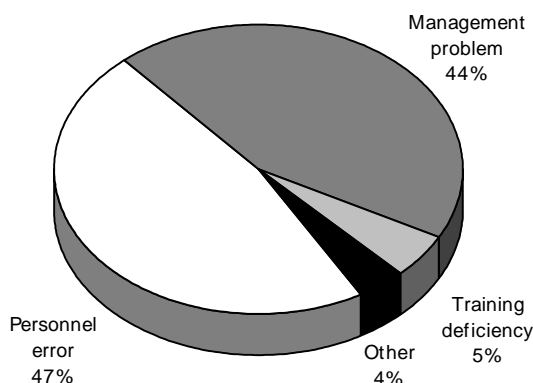
Figure 4-1. Distribution of Root Causes for Failing to Follow Procedures¹

Operating Experience Analysis and Feedback (OEAF) engineers reviewed the Occurrence Reporting and Processing System (ORPS) database and found 383 final reports associated with construction activities and the failure to follow procedures. Figure 4-1 shows the distribution of root causes reported by facility managers for these events DOE-wide from 1990 to present. Personnel errors represented 47 percent of the root causes, and management problems represented 44 percent. Further review of personnel errors shows that 76 percent were caused by procedure not used or used incorrectly; 35 percent of the management problems were caused by policy not adequately defined, disseminated, or enforced.
